This Incident was at Masons Cement works, Ipswich Oct 1941.

Report on the recent demolition of chimney shaft, etc., at  
Mason's Cement Works, Claydon, near Ipswich.

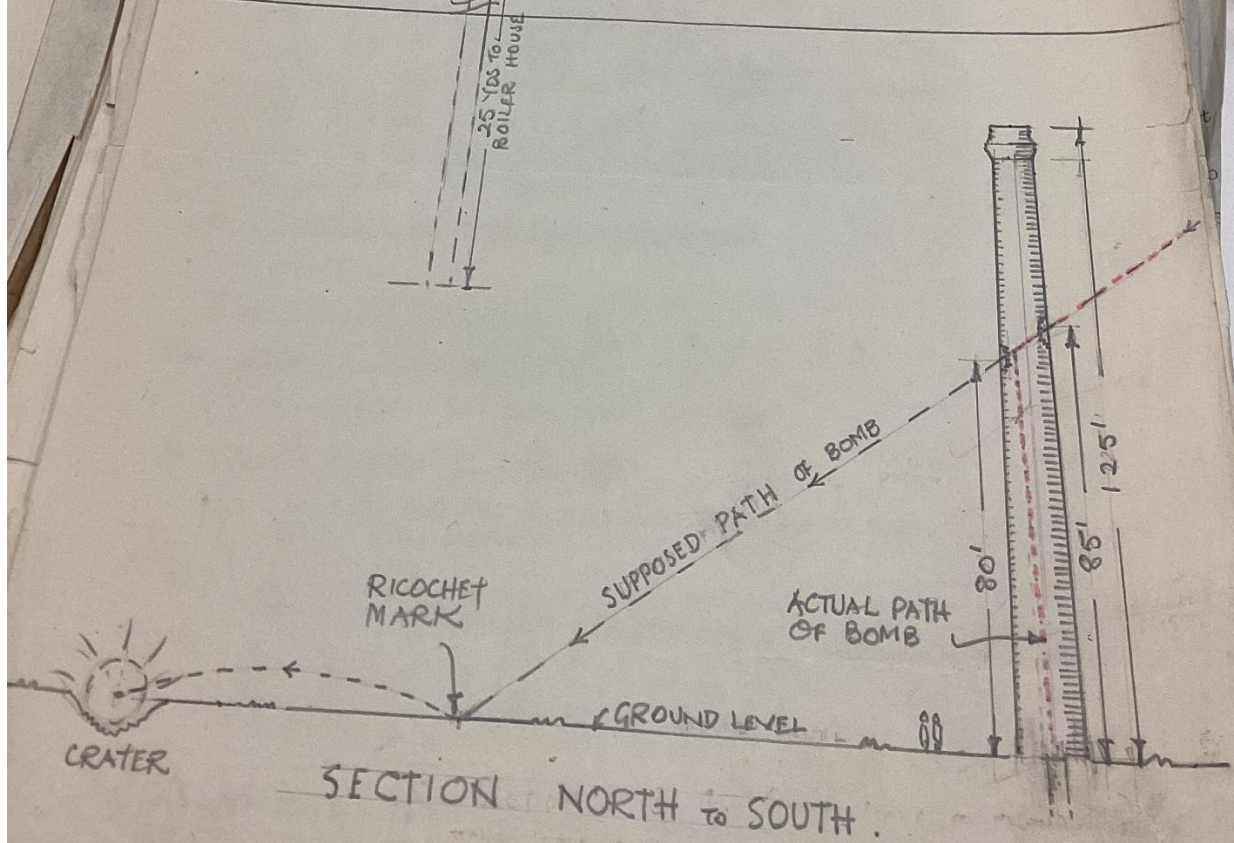
Nearly eight months later, on 26th. September 1941, an explosion demolished this chimney. On investigation pieces of a 50 Kg. bomb were found in the debris, including a portion of the nose, a quarter of the tail and the suspension ring, and it would appear that the February bomb entered the northern wall of the shaft at the 85 ft. hole, struck the opposite south wall of the shaft at the lower level, knocked out the brickwork there, and then fell down the inside of the shaft, coming to rest on the concrete floor of a disused boiler flue (See sketch attached).

The writer (Major Barefoot) visited the Works and was shown the site by Mr. H. Mason, the Managing Director, who said that the heat from the other boiler-flue (in use) might occasionally reach 400° F. but that the disused flue had not been used this year, and was permanently shut off by a fixed damper from any other boiler. There is no question of sabotage, as it was impossible to reach the position where the bomb is assumed to have been lying. This position is indicated by explosion marks in the dis-used flue.
